IGS09-03 LP Turbine Last Stage Bucket Replacement Proposals Evaluation

IGS LP TURBINE LAST STAGE BUCKET REPLACEMENT

IPP, Unit 2 LSB Erosion (270T151)

TO: George Cross
FROM: Wes Bloomfield
DATE: June 12, 2008
SUBJECT: Recommendation to replace low pressure turbine last stage buckets

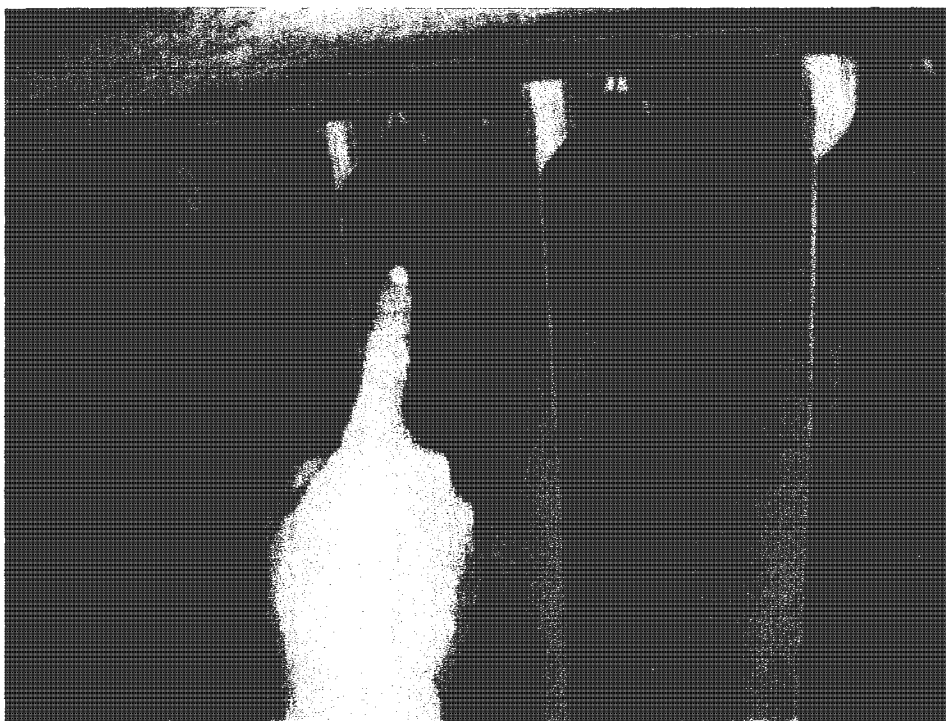
LP C TE L-0 1

The L-0's on LP A, B, and C were visual and NDE examined per TIL-1521 and GEK46354. As noted in past IPP QC records there is erosion on Inlet Side of all L-0 Buckets.

PRO comments are profile doesn't cause to much short term concern but should be replaced at next major outage.

Monitor LP L-0's per TIL-1521 and GEK46354 and replace on next major outage.

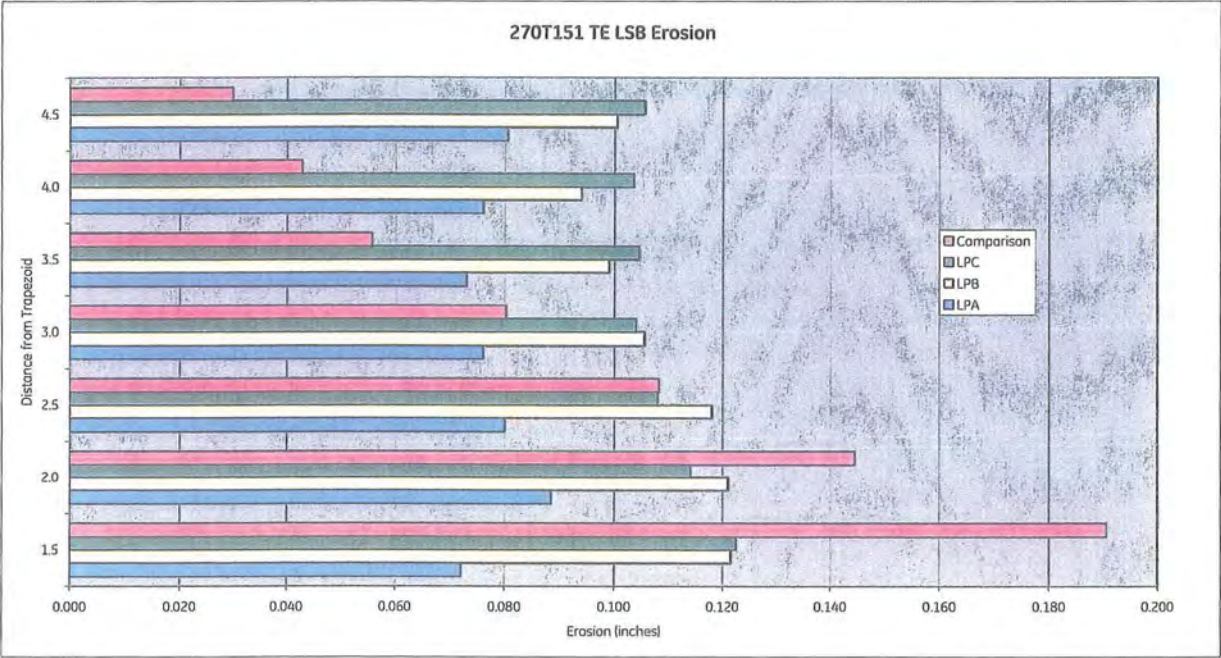
Comparison of IPP's erosion to erosion measured on a 33.5" D8 turbine where LSBs were replaced.

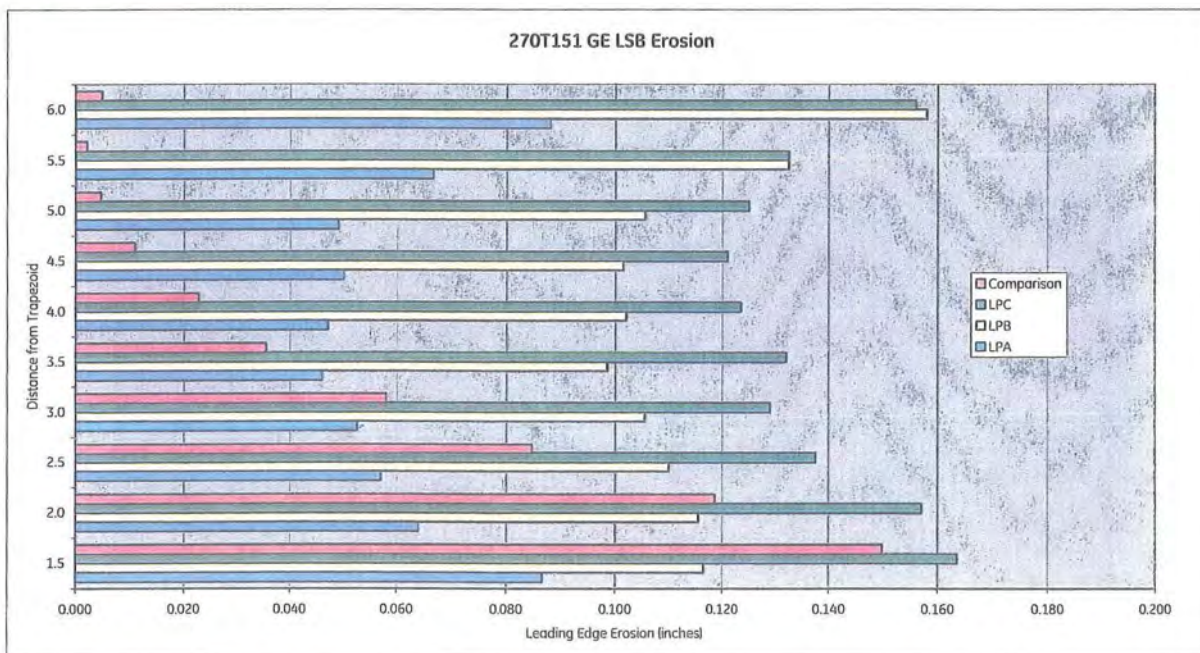
Comparison of IPP's erosion to erosion measured on a 33.5" D8 turbine where LSBs were replaced (continued)

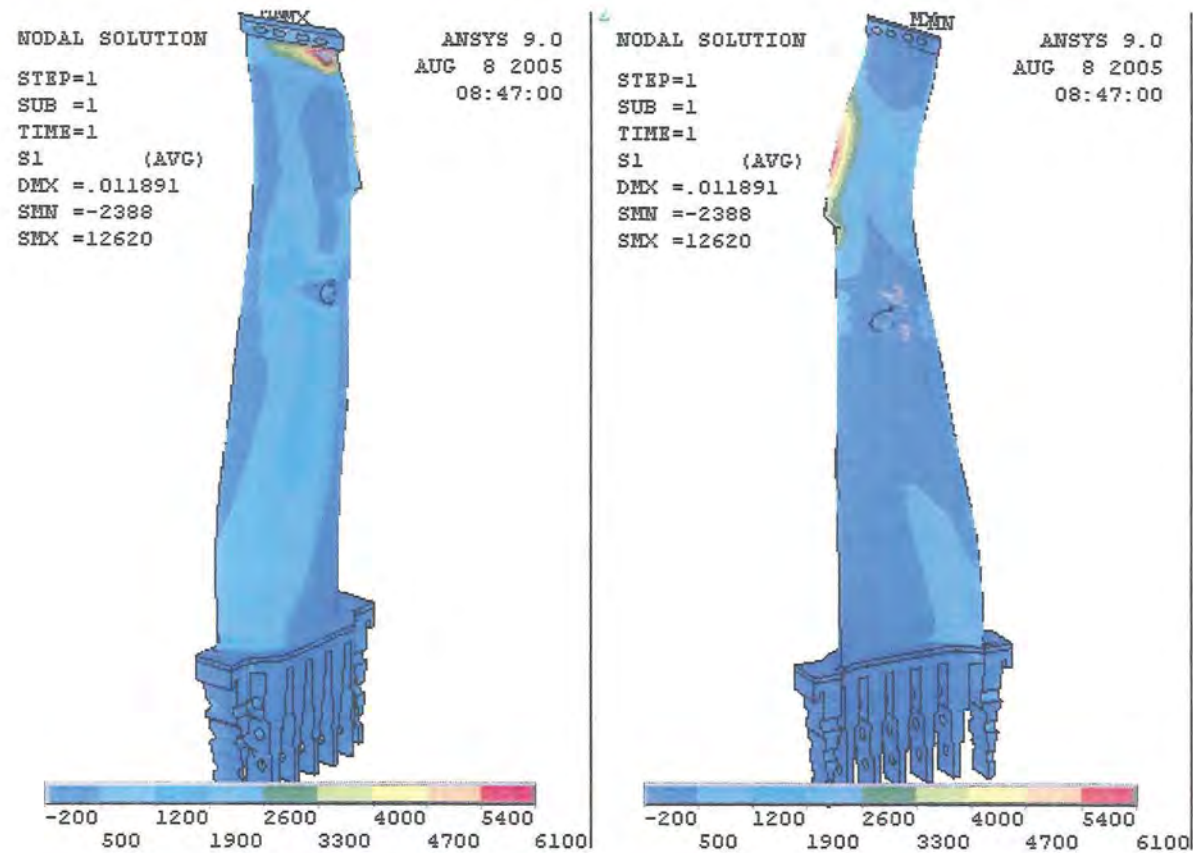
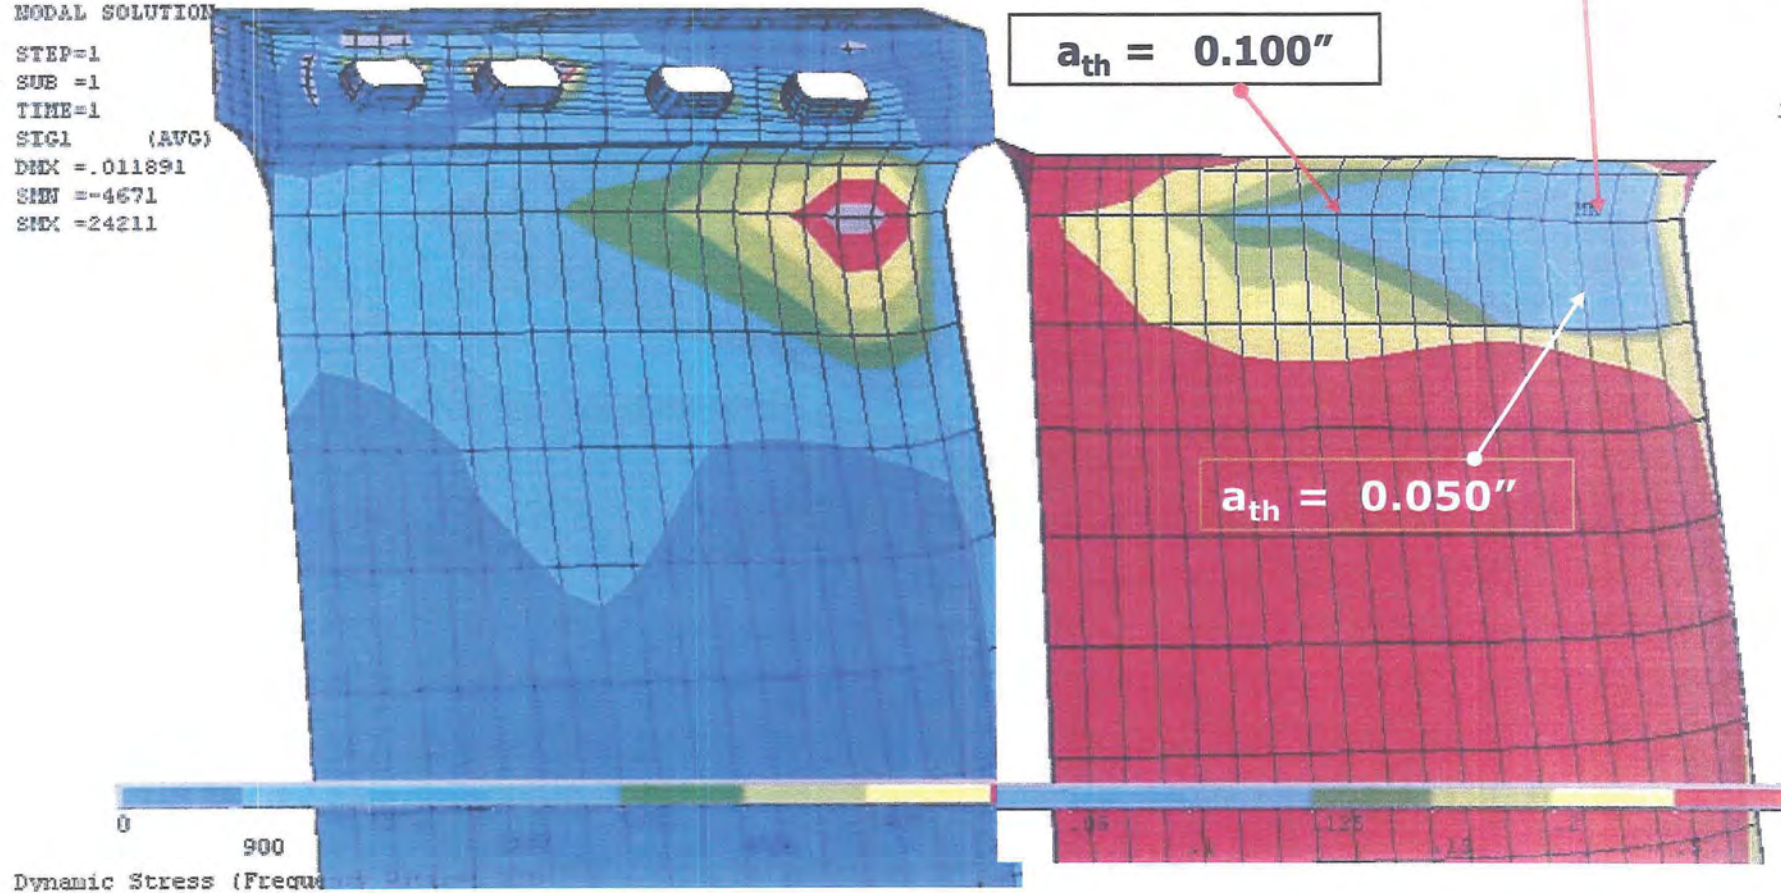
GE 30" LSB Failure Analysis

Resonant Stress Distribution
Mode B, $f = 421$ Hertz

GE blade is tuned at 421 hertz 420 hertz = 7/rev, Mode II Resonance

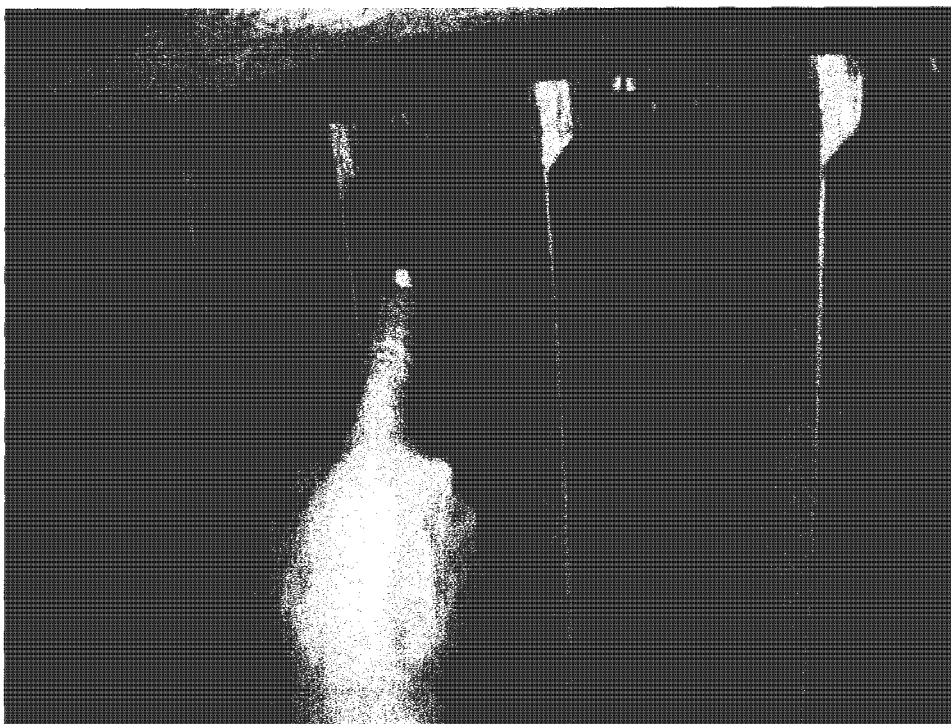
LP C TE L-0 1

PRO comments are profile doesn't cause to much short term concern but should be replaced at next major outage.

Monitor LP L-0's per TIL-1521 and GEK46354 and replace on next major outage.

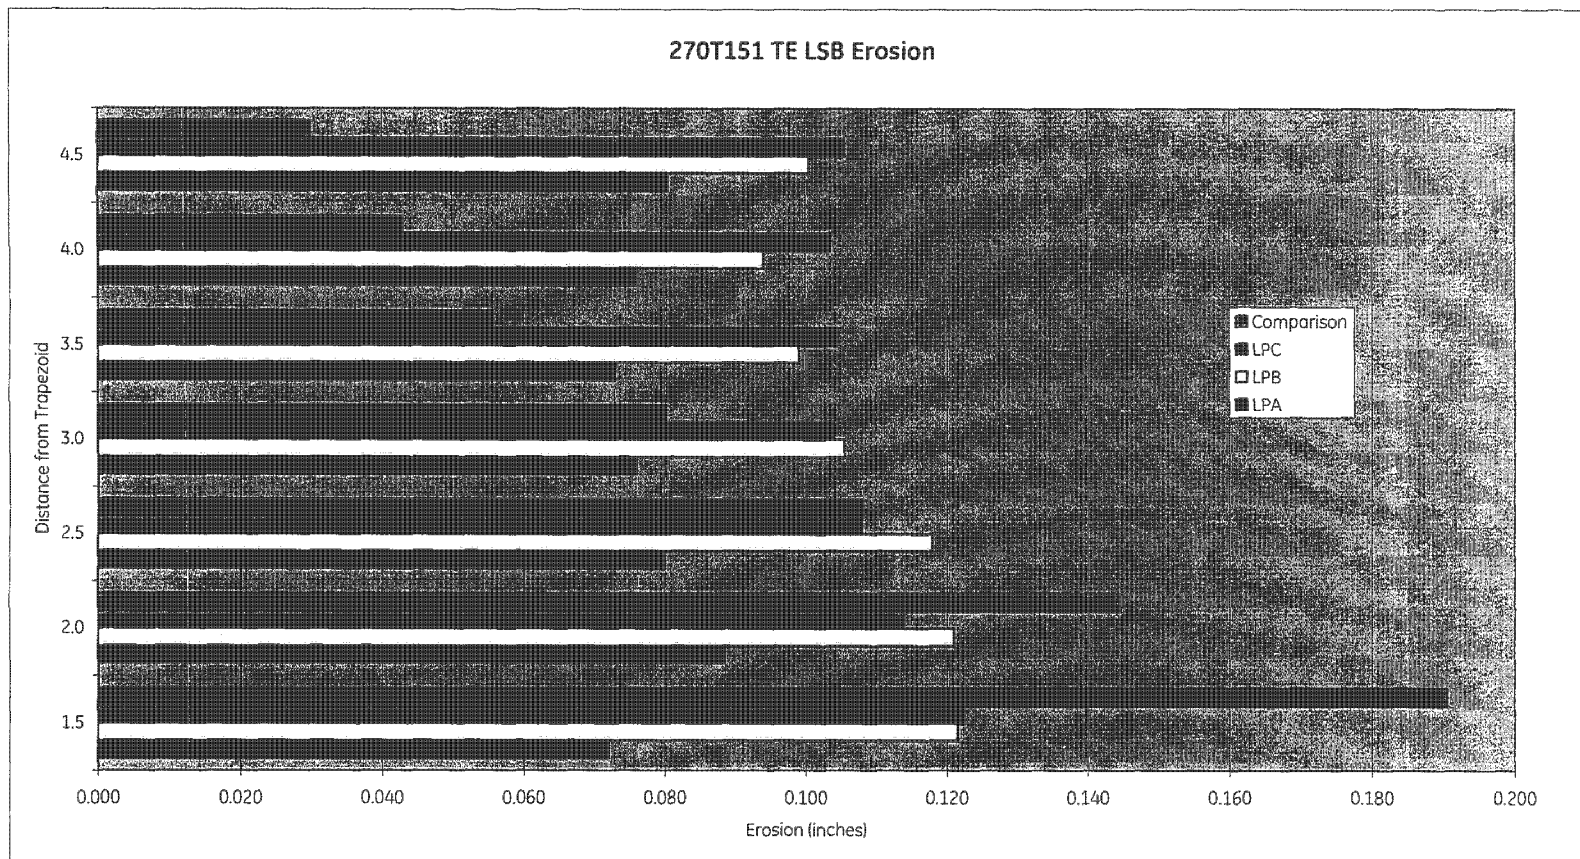
Comparison of IPP's erosion to erosion measured on a 33.5" D8 turbine where LSBs were replaced.

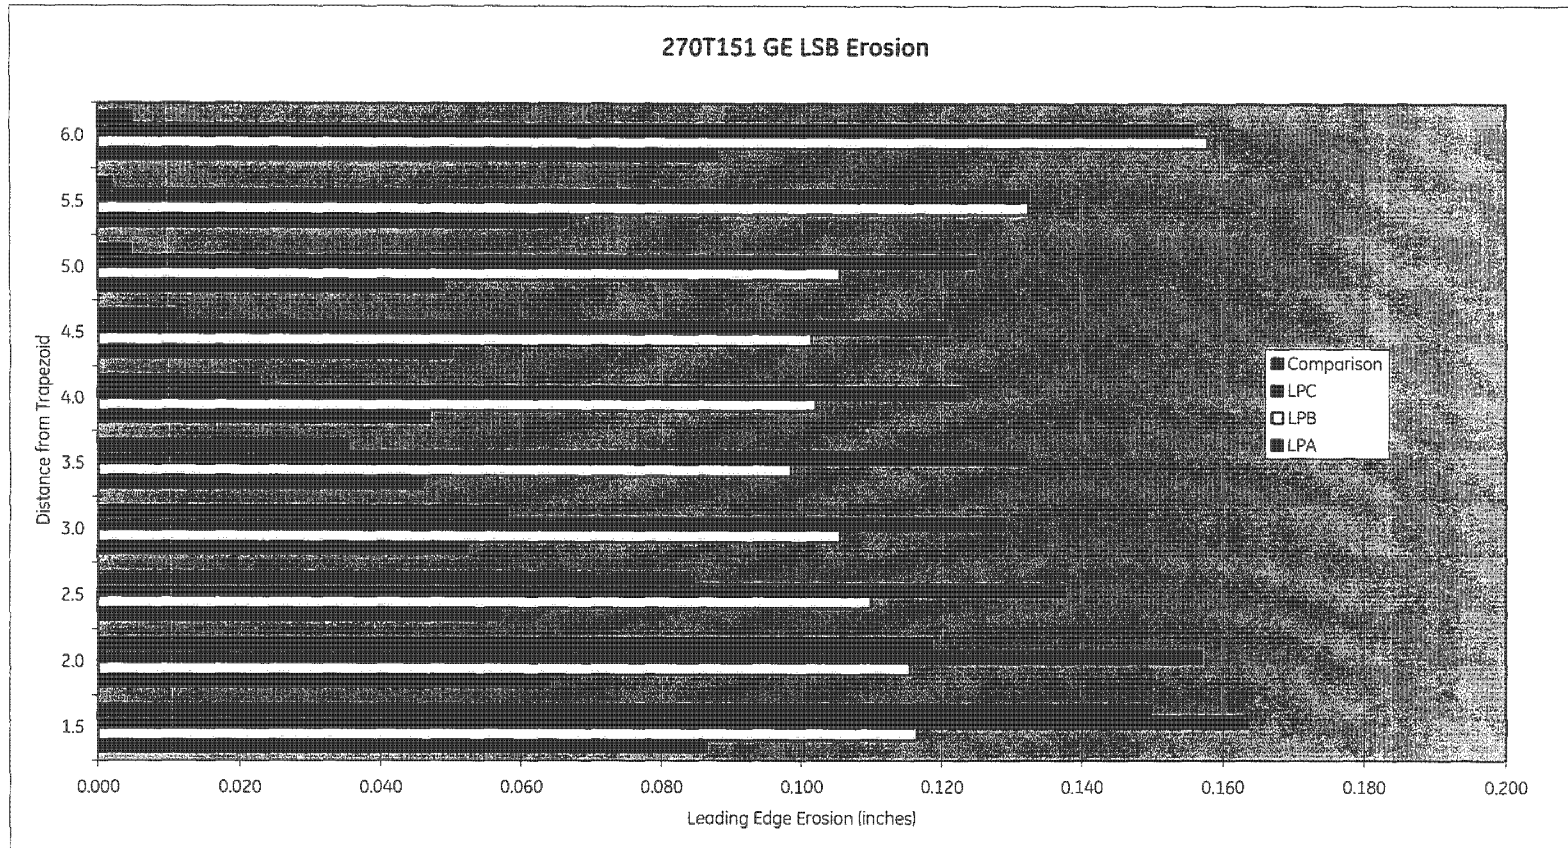
Comparison of IPP's erosion to erosion measured on a 33.5" D8 turbine where LSBs were replaced (continued).

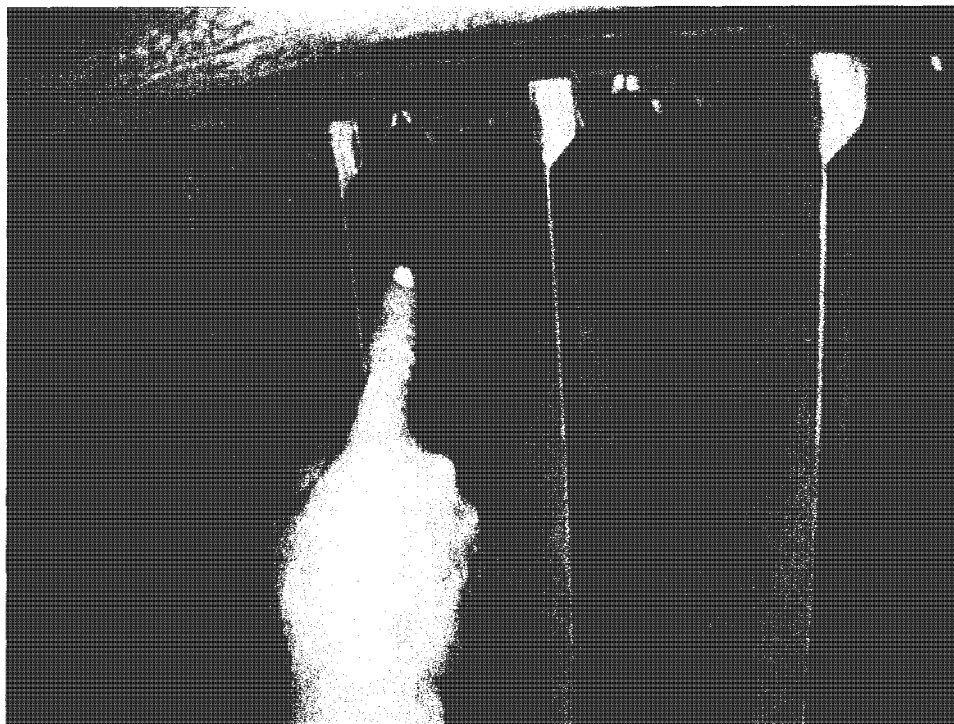
LP C TE L-0 1

PRO comments are profile doesn't cause to much short term concern but should be replaced at next major outage.

Monitor LP L-0's per TIL-1521 and GEK46354 and replace on next major outage.

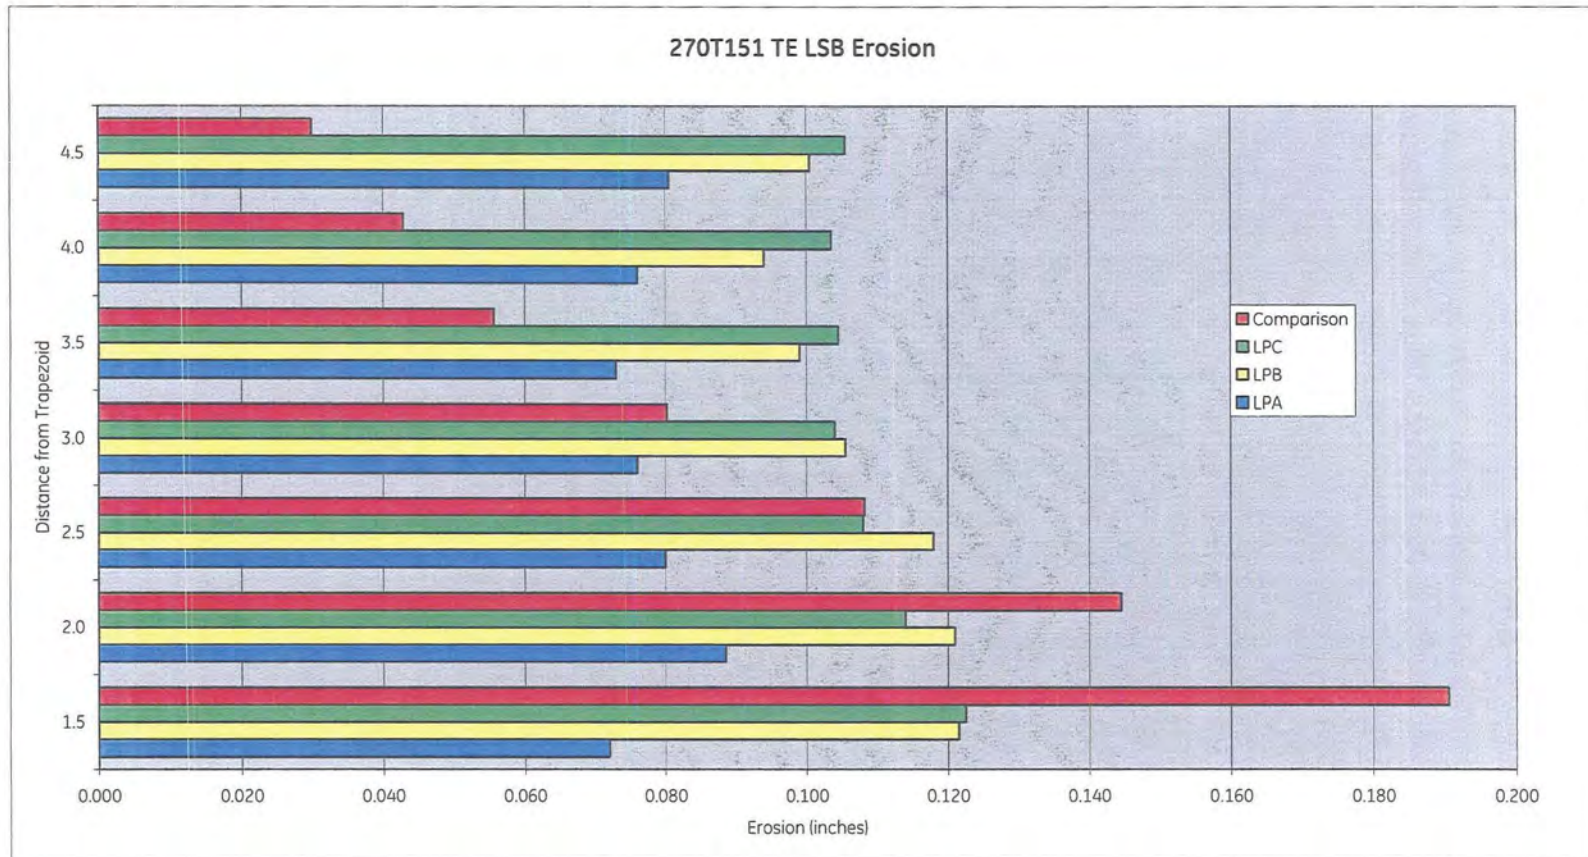
Comparison of IPP's erosion to erosion measured on a 33.5" D8 turbine where LSBs were replaced.

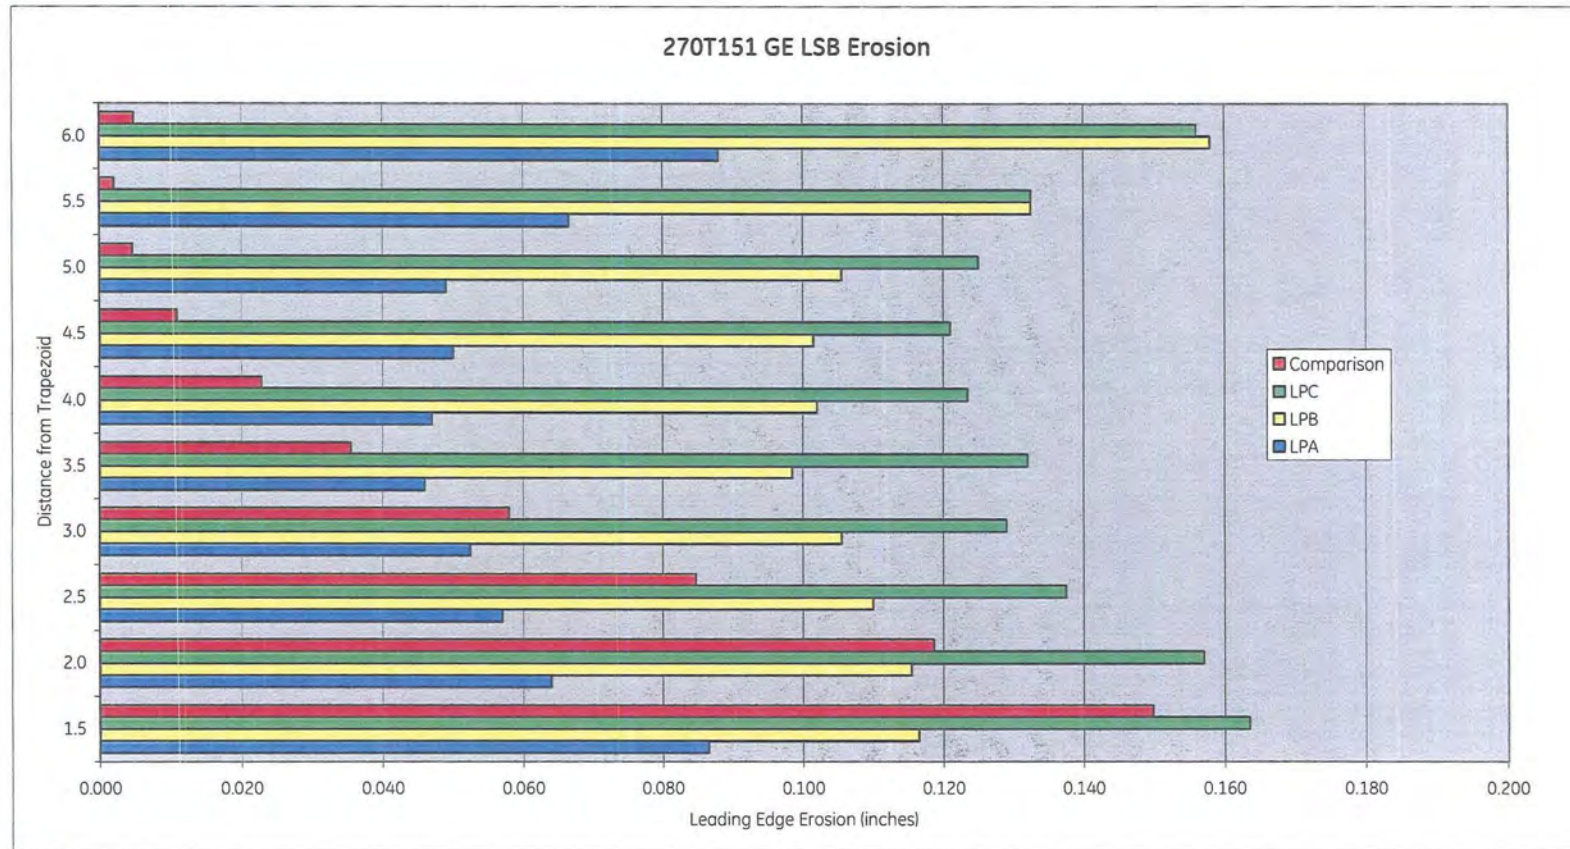
Comparison of IPP's erosion to erosion measured on a 33.5" D8 turbine where LSBs were replaced (continued).

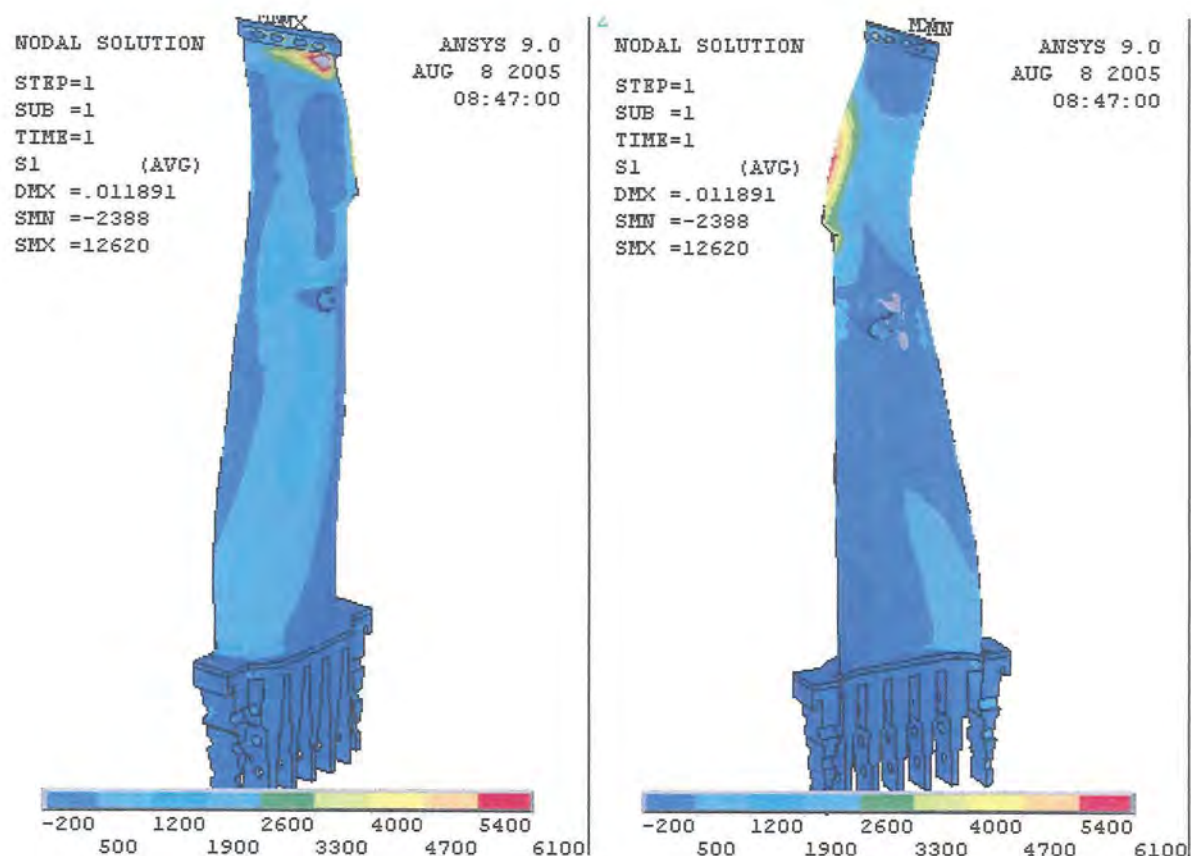
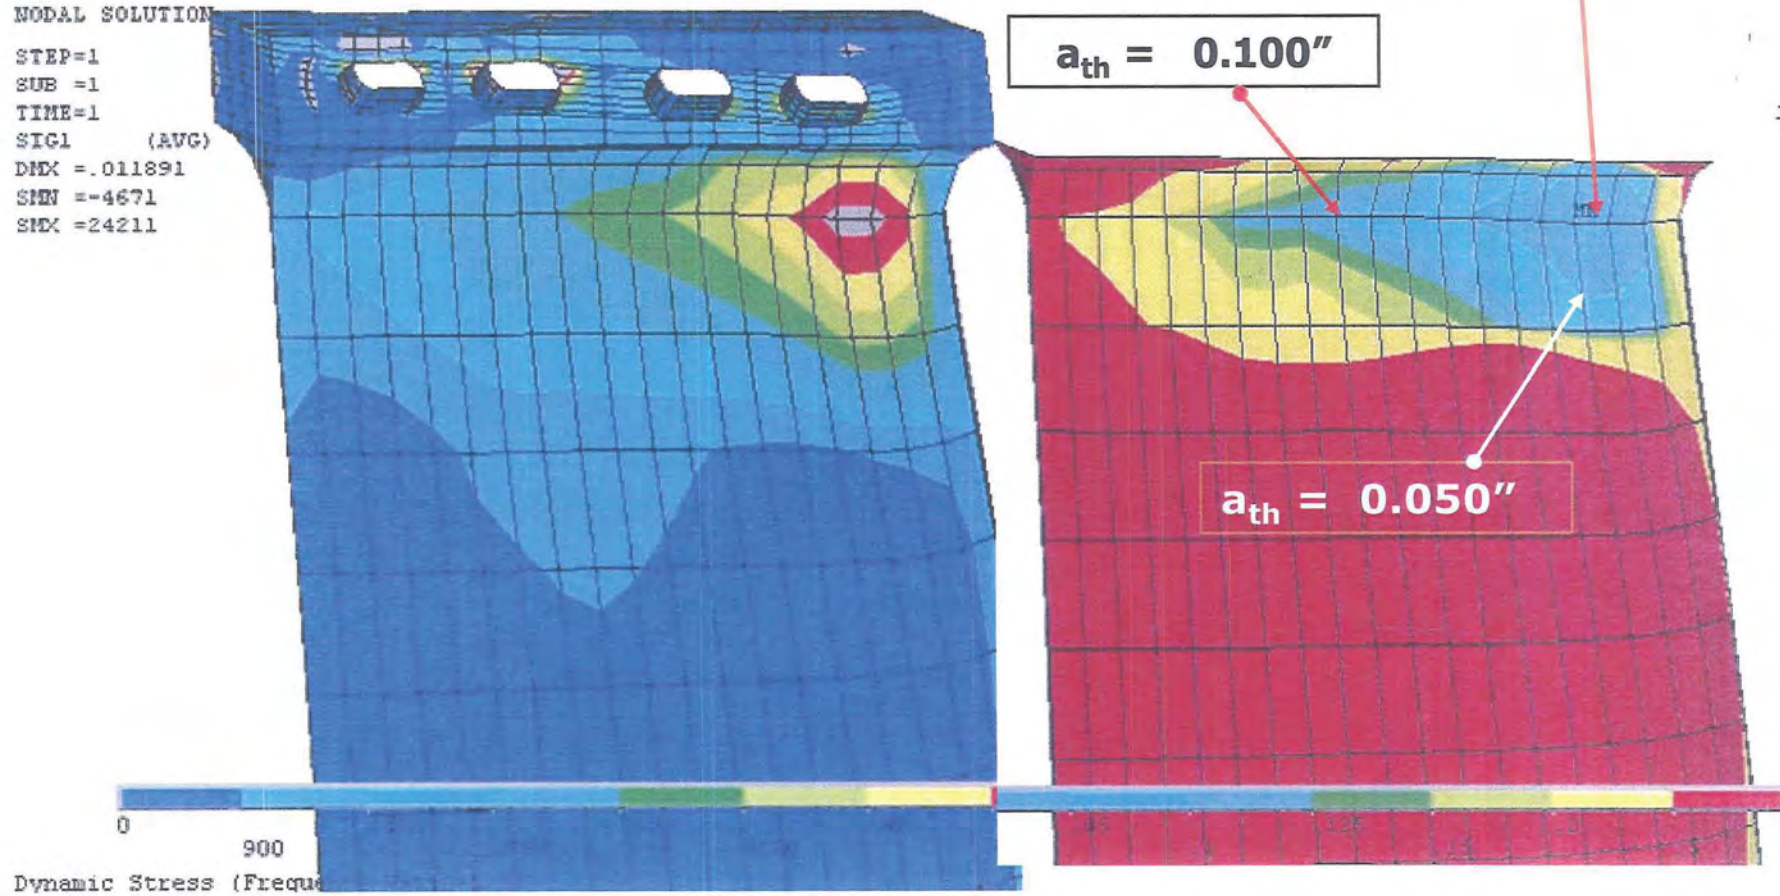
GE 30" LSB Failure Analysis

Resonant Stress Distribution
Mode B, $f = 421$ Hertz

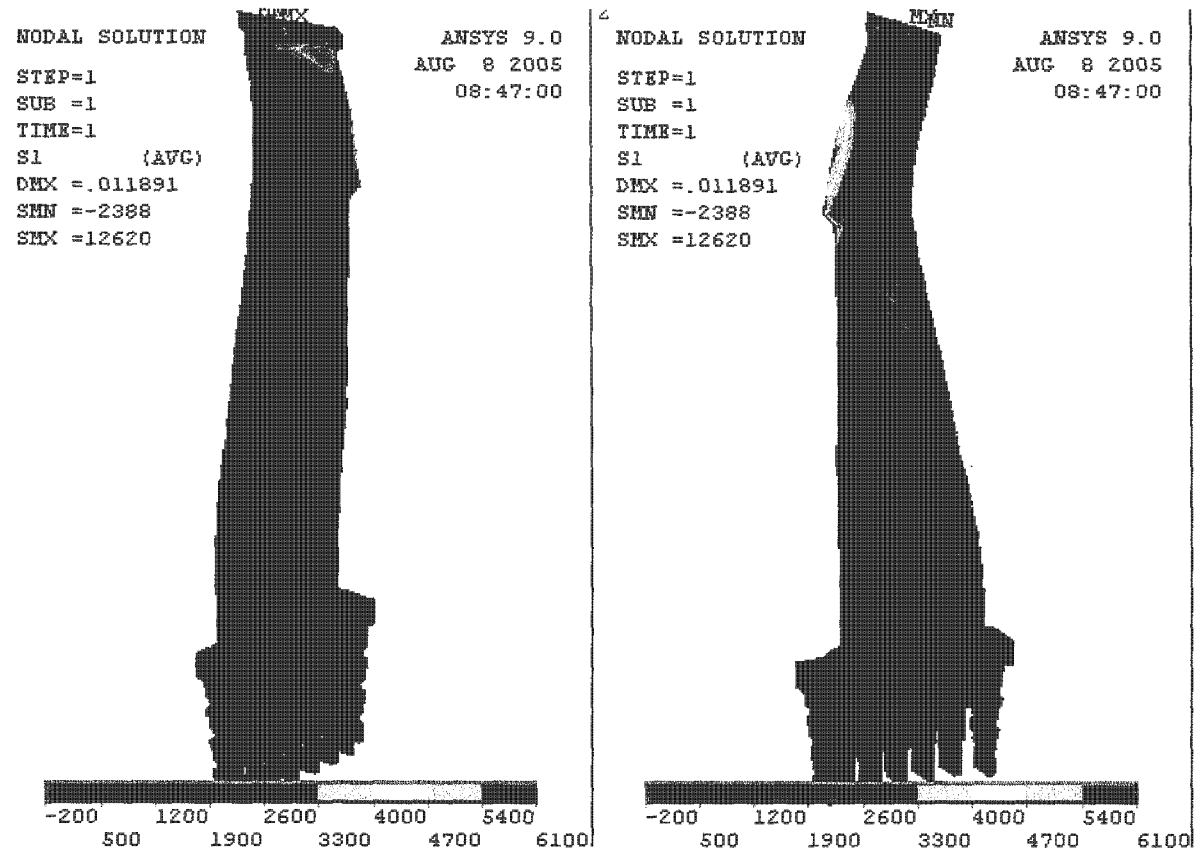
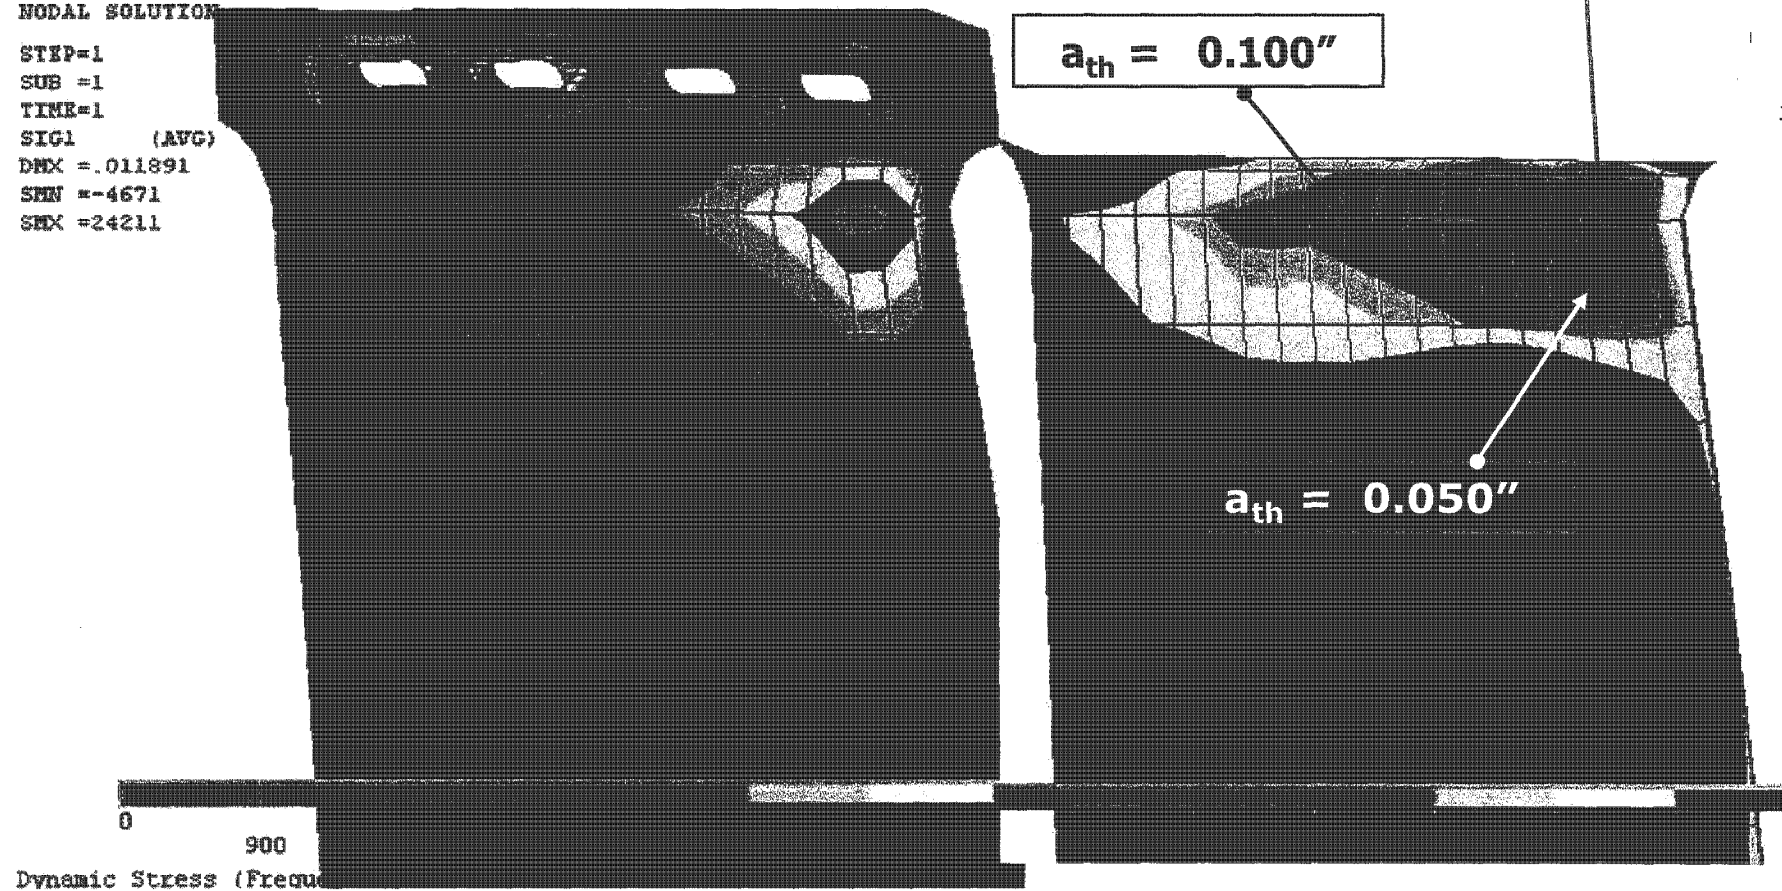
GE 30" LSB Failure Analysis

Resonant Stress Distribution
Mode B, $f = 421$ Hertz

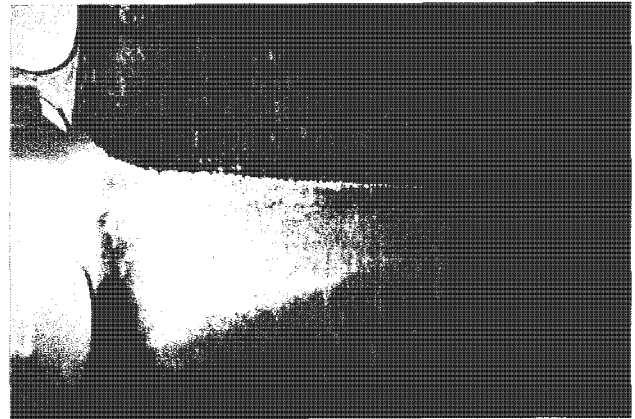
Figure 2: Erosion Profile on a Self Shielded Jethete Material L-0 Bucket

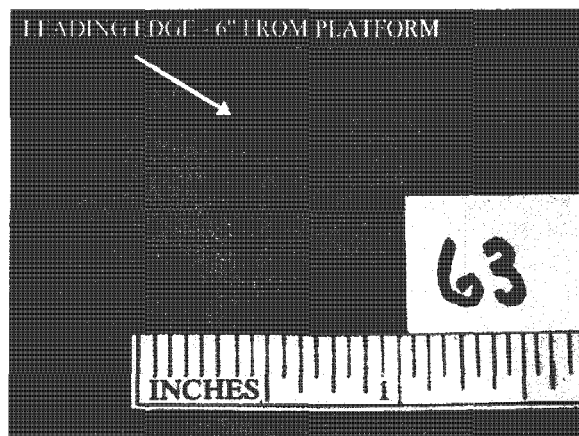
2004: In August, HTG1 suffered an in-service failure of a 33.5" self-shielded last stage bucket. The failure occurred when the unit was at steady-state full load conditions. The crack initiated at an erosion crevice on the leading edge of the blade and traveled across the blade foil. M&P Laboratories, Schenectady, NY, determined high-cycle fatigue was the failure mechanism. When the bucket tip and spacer block separated, collateral damage occurred to the other buckets in that stage and the mating diaphragm. The mating diaphragm and other buckets in the failure row sustained damage from the liberated tip and spacer block, but collateral damage was minimal. Turbine shaft vibration did not exceed a level that would initiate damage of seals. Because of leading edge erosion, and cracks that were found at the tenon holes of 30 other buckets, the decision was made to replace both rows of the Huntington L-0 buckets with new MK IV self-shielded buckets. Huntington Unit 1 had a combination of shielded and self-shielded buckets.

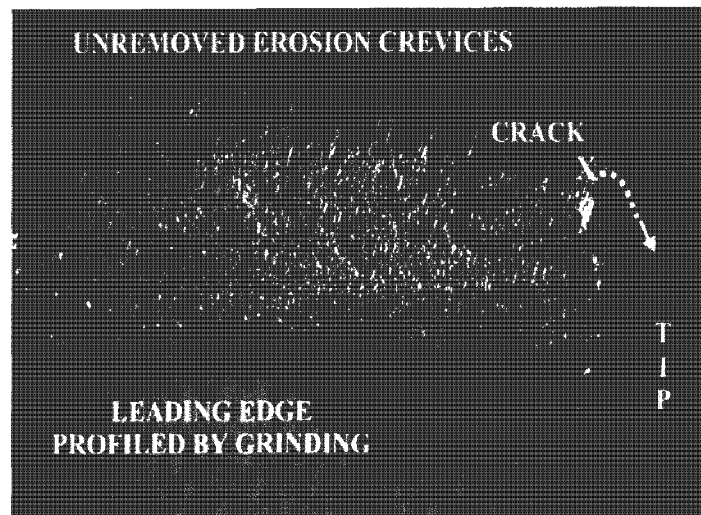
In March of 2004, when the replacement buckets were approximately ~~nine years~~ old, the first in-service failure of these buckets occurred. While the unit was in operation, the tip of a bucket liberated and necessitated a two-week outage for repairs and replacement of several buckets. An analysis of the failed bucket disclosed that a crack had initiated in a moisture-erosion crevice approximately 1/2" from the original nose of the bucket, near the tip where the deepest erosion crevices existed. The ~~crevice~~ notch served as an initiation site for a high-cycle fatigue crack.

After the failure, the last stage buckets were inspected, the damaged buckets were replaced, and attempts were made to eliminate the worst of the foreign object damage along the bucket leading edges near the tip of the buckets by grinding and contouring the erosion areas. The unit was returned to service with the intent of operating it until a scheduled dismantled inspection in February 2005.

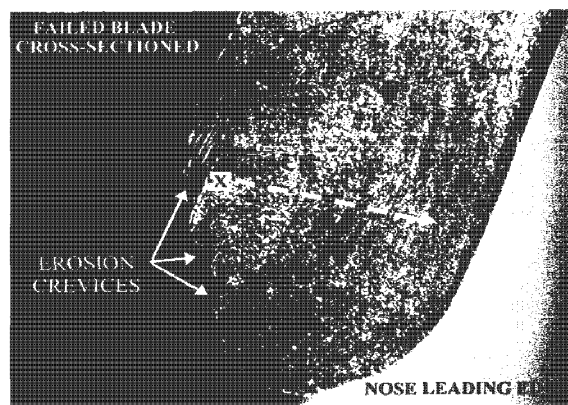
But, during the first week of January 2005, another last stage bucket failed while the unit was in service. The crack location and failure mechanism was nearly identical to the failure that had occurred previously. The failure was in a blade that had been contoured in March.
